ARIZONA DEPARTMENT OF TRANSPORTATION

REPORT NUMBER: FHWA/AZ-82/181/FINAL REPORT

PAVEMENT CRACKING INVENTORY STUDY

James S. MacKenzie
Novak Dempsey & Associates

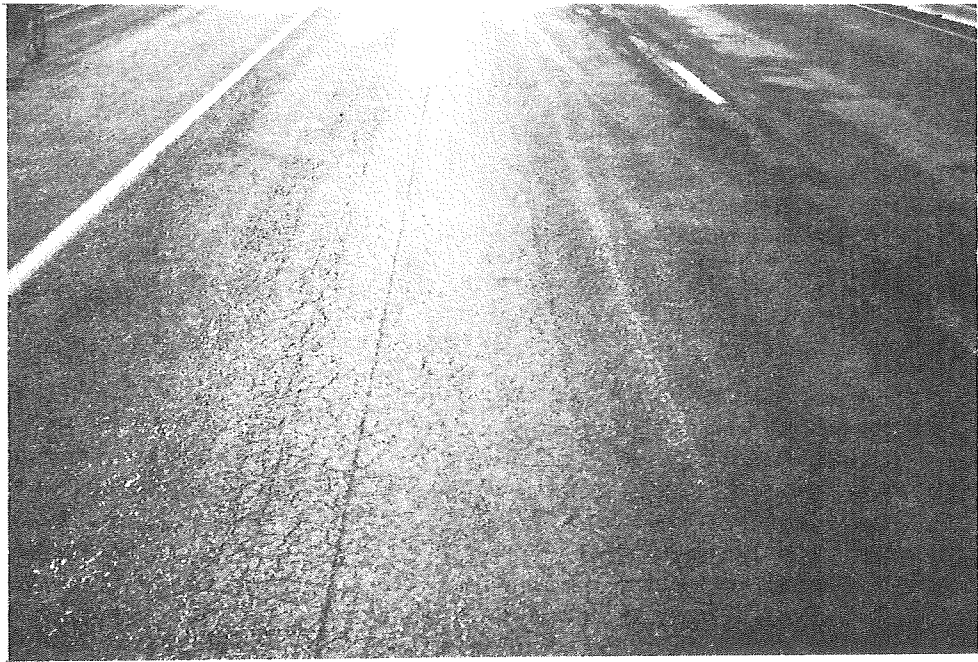
FIGURE 4.
TEST SITE 1, SR 87-OUTSIDE N BOUND LANE.

(a) The first test site was on State Route 87, a north-south rural inter-city highway south of Chandler, Arizona between Mileposts 160 and 161. This is a 4-lane asphalt highway. The pavement surface cracking condition is characterized by fine to medium alligator cracking with some longitudinal cracking in the wheel tracks as shown in Figure 4. The video test was taken on the morning of the 15th of December shooting with the sun behind the vehicle which was proceeding in the north bound direction.

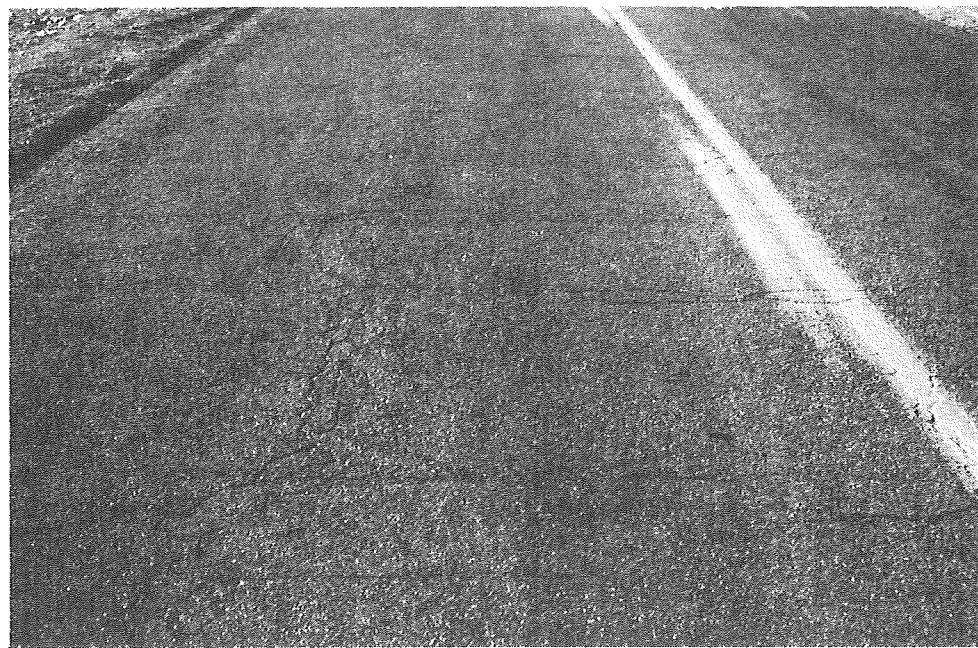
FIGURE 5.
TEST SITE 2, SR 287-E BOUND LANE.

(b) The second test site was on State Route 287, from Mileposts 135 to 136. This is an east-west route located west of the city of Florence, Arizona. The pavement is characterized by transverse cracking, block cracking and random cracking as shown in Figure 5. The video test was taken in the afternoon of the 15th of December in the east bound direction with the sun at the right rear of the vehicle.

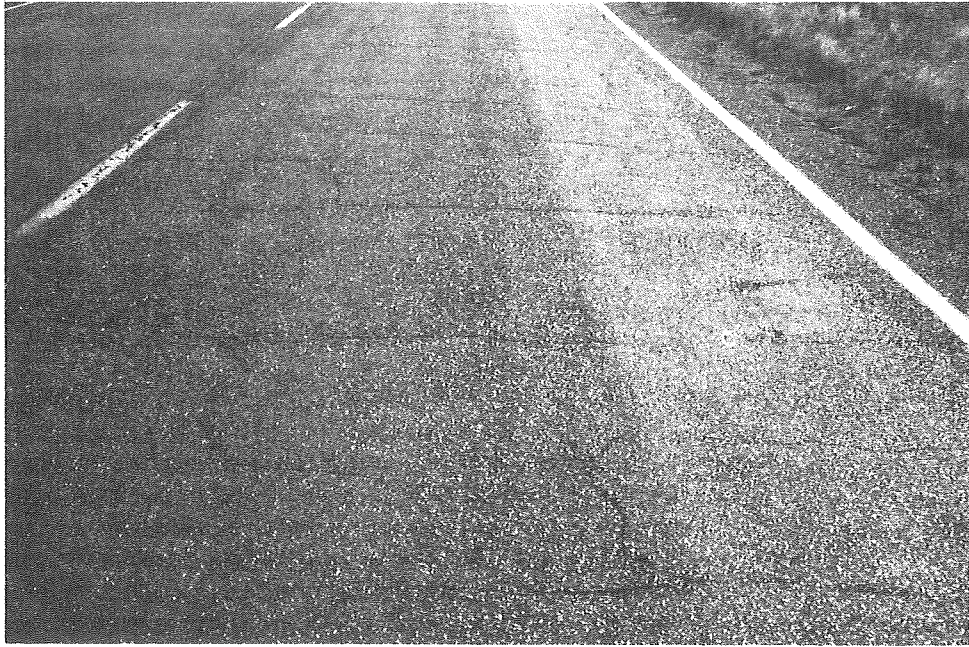
FIGURE 6.
TEST SITE 3, US 89 SE BOUND LANE.

(c) The third test site was on U.S. Route 89, from Milepost 130 to 129. This is a north-south route south of Florence, Arizona. The pavement is characterized by transverse and random cracking and some patching as shown in Figure 6. This test site was selected for the detailed surface evaluation study because of the clarity of the video images obtained at this test site. The video test was conducted on the morning of the 16th of December on the south bound lane shooting into the sun.

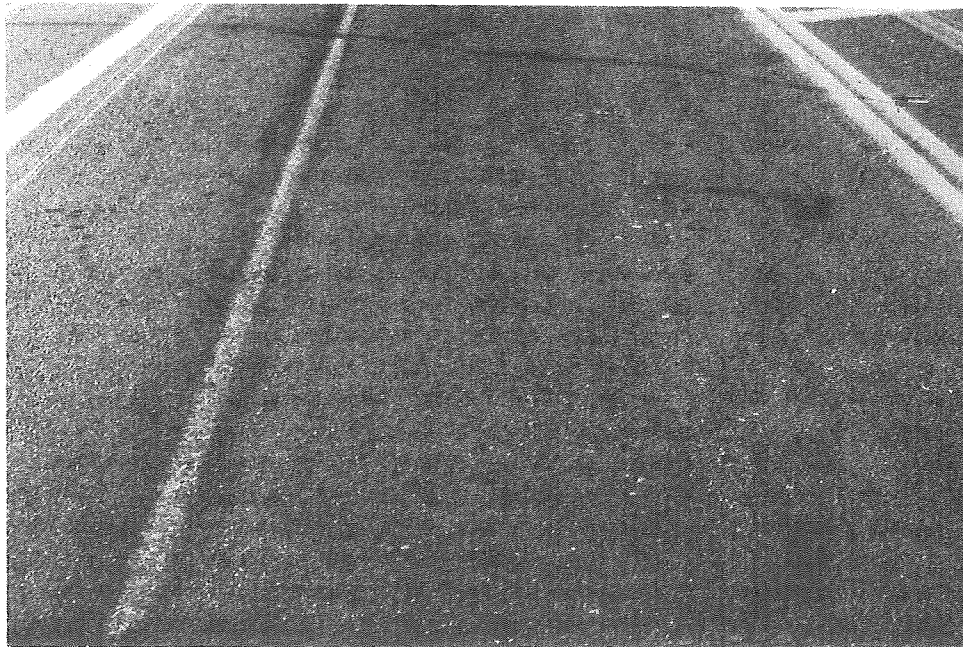
FIGURE 7.
TEST SITE 4, SR 87/287 S BOUND LANE.

(d) The fourth test section was on State Route 87/287 from Milepost 125 to 126. This is a north-south route located south of Coolidge, Arizona. The pavement is characterized by transverse cracking with sealed joints as shown on in Figure 7. The video test was taken on the south bound lane with the sun position ahead and to the right. This test section also had one area of cracked portland cement concrete pavement. This cracking was seen on the video tapes quite clearly.
